Boris Mašić and **Tajana Pleše** report on the excavation of the Monastery of the Pauline Order in Remete, Croatia

On unstable foundations

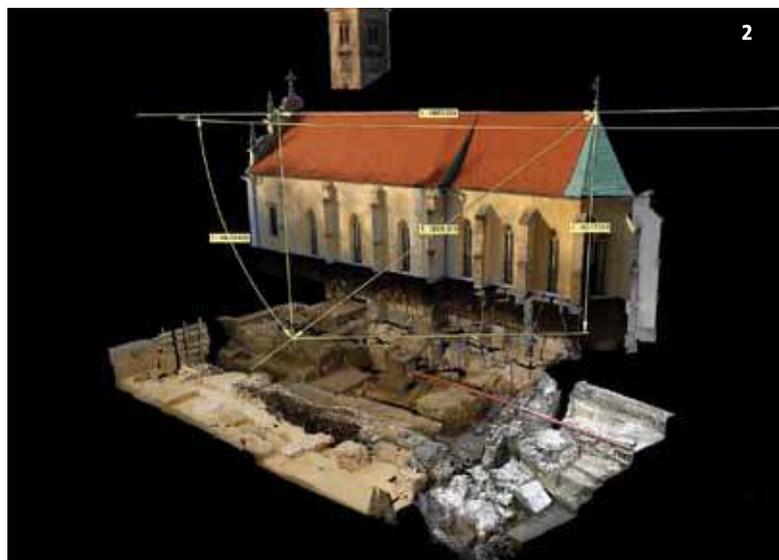
Fig 2. An entire image of the Remete site was obtained through a computer 3D model. Image: Vektra/Geo3D.

Archaeological research carried out along the southern façade of the church from 2007 to 2009 was to force a reconsideration of the dating of the church that currently stands on the site (Fig 2). Furthermore, the remains of what were clearly older architectural features were found during the excavations, and these proved that the site had previously been occupied by two earlier churches.

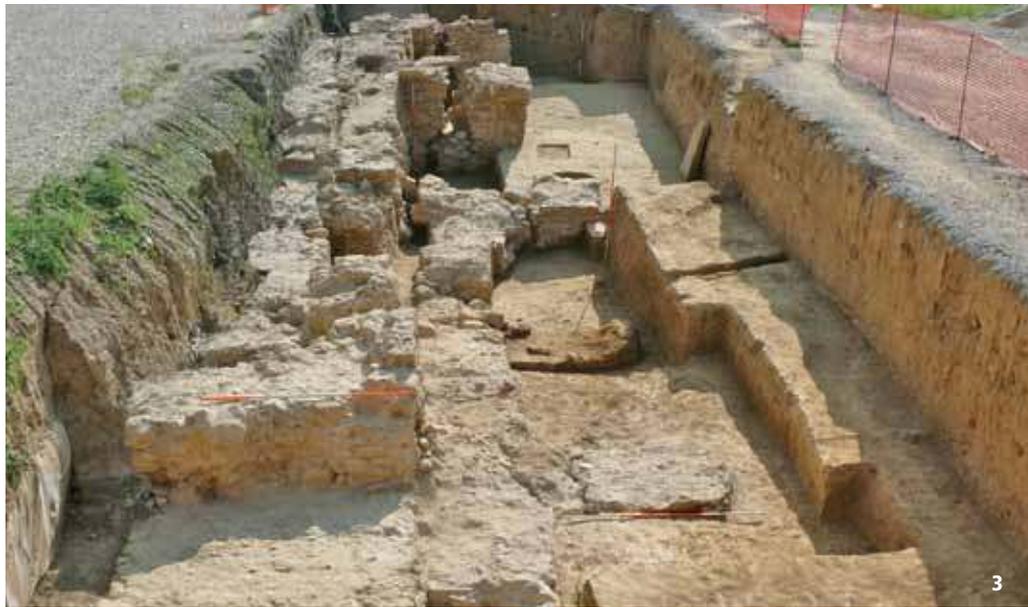
Fig 3. Southern foundations of both early churches excavated at Remete. Photo: M. Gregl.

of these earlier churches indicate that both structures had been seriously damaged by strong geotectonic disturbances in the upper layers of the soil. The excavated wall foundations have tensile fractures running through them, as well as large cracks up to 150cm wide. The foundations of both early churches were broken in the south and east (Figs 3, 4), and there was subsidence along the eastern side of the churches. The original location of the foundations had been displaced by an active landslide that had been moving slowly across the site for

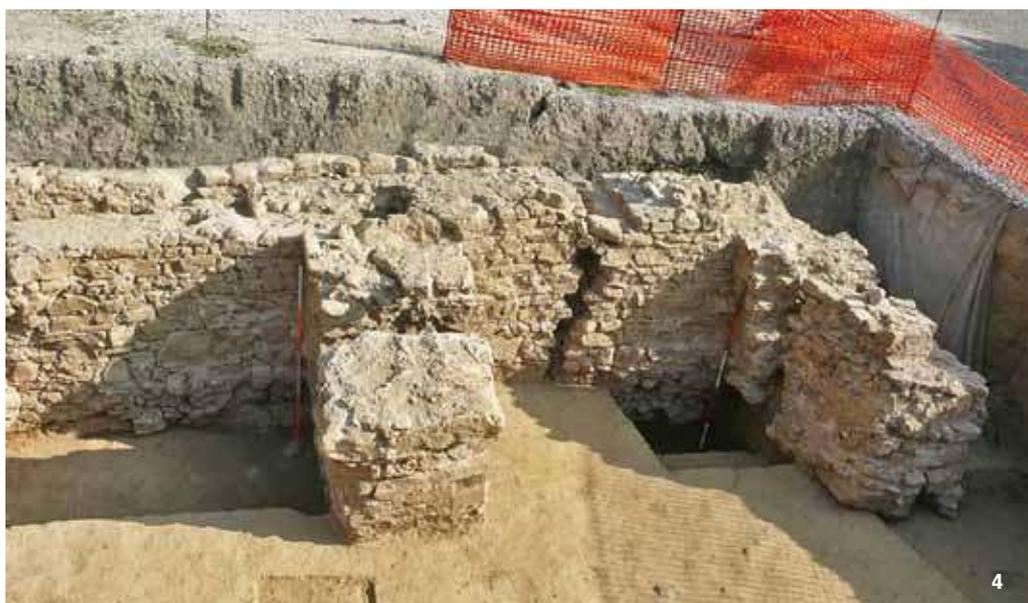
Fig 4. Part of the southern foundation of the chancel of the oldest church. Photo: M. Gregl.

monastic church on the site featured architectural traits common to the Order of St Paul the Hermit: it was constructed with an emphatically longitudinal aspect measuring 30.4 x 10.8m, while the rectangular nave (13.75 x 8.0m) was almost as long as the apse with its semi-circular ending (13.8 x 6.1m). The church was reinforced with solid rectangular buttresses linked to the foundations (Fig 7). In spite of the numerous tensile cracks, the southern foundation of the nave did not undergo any major tectonic shifts, but was partially damaged by later building work, although the rear foundation of the apse did suffer considerable displacement. Along with the damage created by the construction of the second church, it is clear that the destruction of the wall was caused by the shifting of the foundations as a result of the steady movement of the landslide.

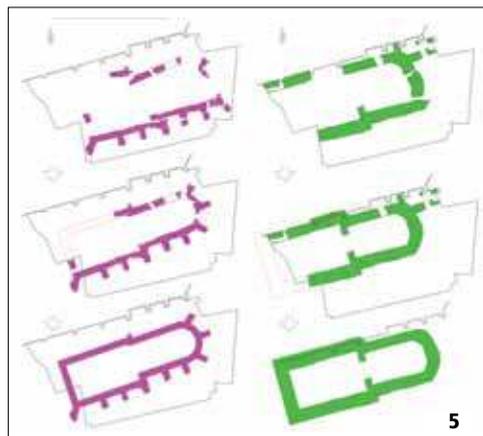
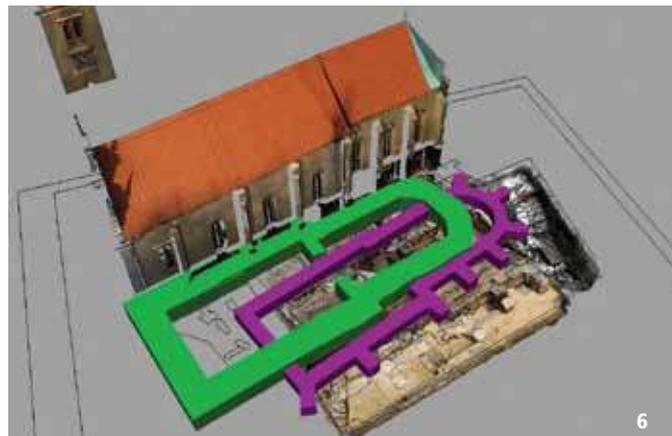
Fig 6. Reconstruction of the original position of the foundations of the churches found in Remete (Image: Vektra/Geo3d).

Thanks to the 3D model, it was possible to produce an ideal reconstruction of the second of the monastic churches found on the site (Fig 6). The model indicated that a similar floor-plan to that used for the building was retained, so the church was also long and narrow (34.4 x 14.35m), with a rectangular nave (14.8 x 8.6m) and an equally long, narrower apse finished off with a polygon (13.75 x 7m). This second medieval church was also damaged by geotectonic disturbances, and, although its northern foundations remained almost entirely in their original location, the southern foundations of the nave and the apse shifted eastwards by almost 1.5m and suffered considerable subsidence.

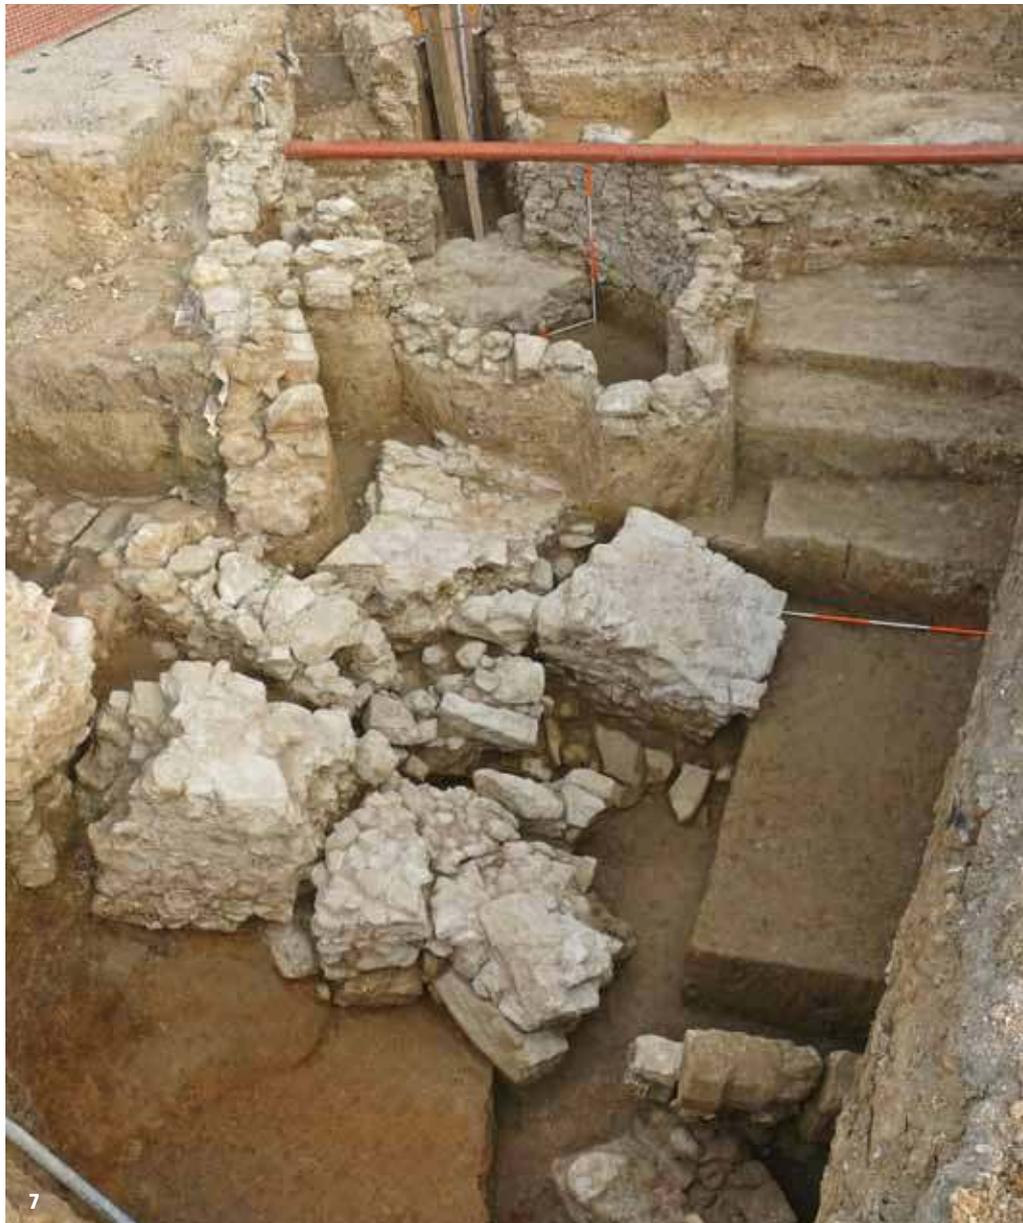
Fig 7. Part of the demolished apse with buttresses of the oldest church in Remete and the oval structure.
Photo: M. Gregl.

part of the southern plateau alongside the current church also revealed a buried structure that was oval in shape and preserved only at the level of the foundations (Fig 7). Interpretation of this structure is probably explained by the Zagreb historian Janko Barlé, who noted in his work *Remete*, published in 1914: 'The whole monastery with church and monastery garden was girt with a wall. It is said that the monastery was connected with Zagreb by an underground passage. This is not true, of course, but it is possible that the Paulines did have some underground secret passage to the mountain, in which they were able in time of need to store their valuables.' This is suggested by the steep northern entry into the structure and the southern exit, which was probably on the slope. Although there is still debate about when it was constructed, it probably dates to the years immediately following the first Ottoman attack on the monastic complex in 1484. Chroniclers of the Pauline

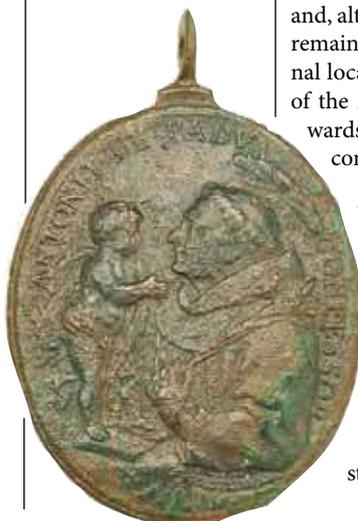
Fig 8. Pilgrimage medal with depiction of the Virgin Mary and St Anthony of Padua, 18th century.
Photo: M. Mustacek.

During the excavations, 282 skeletal remains were also found. These mostly dated from the late 16th to the end of the 18th century (Fig 9), but eight appear to have been dug at the turn of the 13th and 14th century. The deceased were placed on their backs, often in wooden coffins (which can be concluded from the finds of wood remains and iron nails), with their hands placed on their pelvis or chest. While the oldest graves contained no artefacts beyond skeletal remains, later burials contained crosses, rosaries, buttons and belt buckles. The most numerous items found with later burials were medals, either depicting saints, such as St Benedict with the Virgin, or from pilgrimage sites in Mariazell, Passau, Marija Bistrica, Altötting, Dorgen, Wies, Częstochowa, Loreto, Marianka, and Rome (Fig 8).
